TITLE: *Innovative and Durable Repair Solutions for Concrete Pavement at Hartsfield-Jackson Atlanta International Airport*

AUTHOR(S): W. Charles Greer, Jr., Subash Reddy Kuchikulla, John Rone, and James L. Drinkard

VENUE: *Proceedings, 12th International Symposium on Concrete Roads, organized by the European Concrete Paving Association EUPAVE and the Czech Research Institute, Prague, Czech Republic*

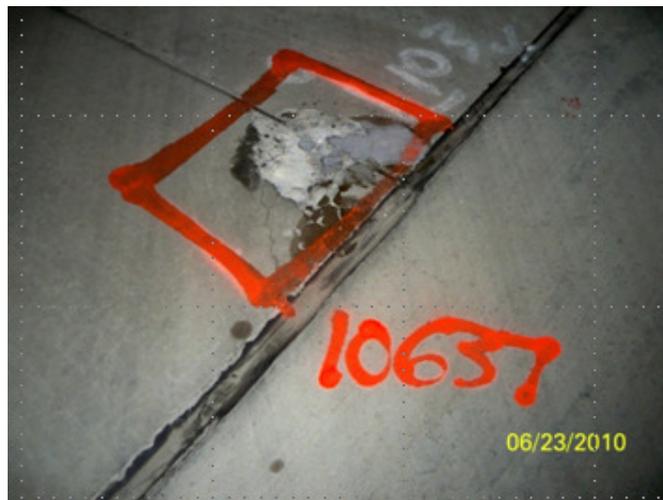
Figure 1: Typical spall distress.

The most common distress in terms of frequency is spalling along longitudinal or transverse joints. These are typically due to failure of the female side of keyways in the longitudinal joints or failure to maintain proper separation across a joint when previous spalls were repaired as shown in Figure 3. Keyways have not been used in pavements constructed at ATL since the early 1980's (Greer, Kuchikulla, Masters and Rone, 2013). The spall may also be an area where a previous patch has come loose or delaminated.

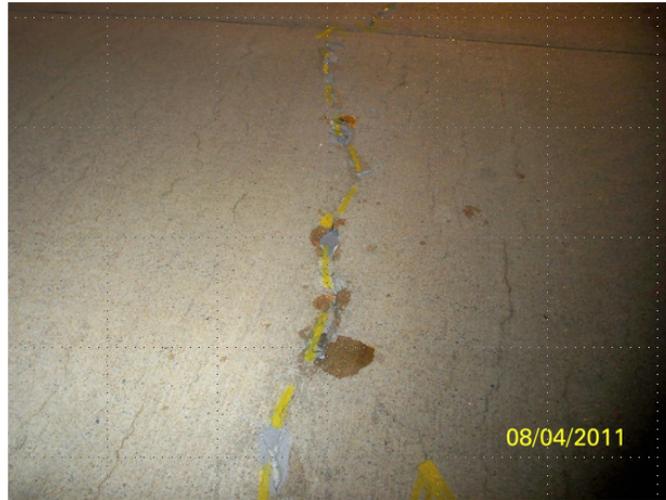
Figure 2: Typical crack routing and sealing distress.

Joint seal damage has generally been the result of failure of the bond between the sealant material and the adjacent concrete to which it was bonded. This has been attributed to

failure to properly clean and/or dry the concrete surface prior to placement of the sealant material.

Another common repair is sealing of cracks in the surface of the PCC slabs. This is accomplished by routing the crack out to a width of 9 mm (3/8 inch). The routed crack is then sandblasted and cleaned by blowing debris out of the routed crack with an air wand. A backer rod is then inserted in the routed crack followed by installation of the sealant. The sealant material used is Dow 888 or approved equivalent.

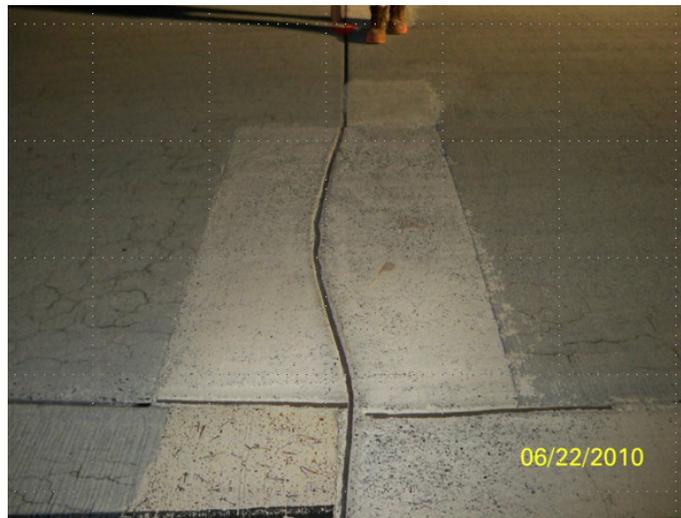
Figure 3: Failure to maintain proper joint alignment and continuity --- future distress.

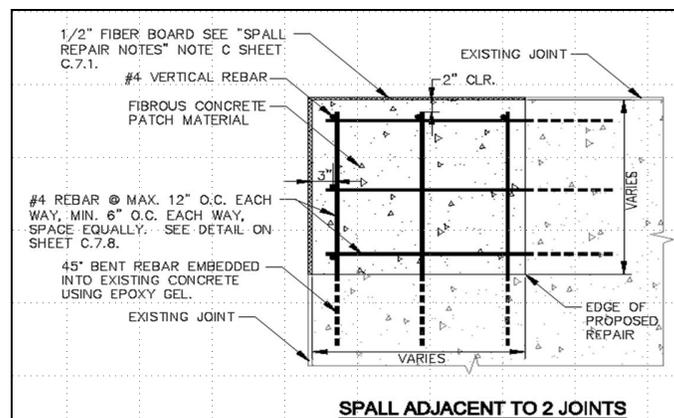
Figure 4: Schematic drawing for spall repair.

A key factor in the establishment of durable PCC repairs at ATL has been the development of standard repair concepts followed by implementation of these concepts in the design of the repairs. Patching of spalls is one of the most common repairs at ATL. For over 25 years, the concept for repair of spalls has involved removal of the distressed concrete down to sound concrete that is relatively level with planar sides through sawing, bush hammering and cleaning of the exposed surface. Vertical holes are drilled into the bottom of the area to be patched along the sides where the adjacent joints are located. The holes are maintained at least 5 cm (2 inches) from the edge of the joint. No. 4 (13 mm or 1/2 inch) reinforcing steel bars are then epoxied in the holes. Holes are drilled in the exposed sides opposite the joint sides of the patch area in a downward direction at approximately 45° with the horizontal. No. 4 bars with a 45° bend are then epoxied in the holes. The bent bars are not installed across the joints so that proper joint movement can still occur.

A horizontal reinforcing steel mat of No. 4 bars, with a variable spacing each way, is then placed so that a cover of 40 mm (1.5 inches) over the steel can be maintained. A tolerance of 13 mm (1/2 inch) is allowed for the cover of the steel mat. The variable spacing for the bars in the steel mat is a minimum of 15 cm (6 inches) to a maximum spacing of 30 cm (12 inches) on center. The steel generally provides a tensile attachment of the patch to the sound concrete that far exceeds the tensile capacity of the sound concrete. The steel also provides integrity to the patch should cracks develop in the replacement concrete. Fiberboard 13 mm (1/2 inch) thick is used at the faces of adjacent slabs in order to maintain a proper joint separation between the repair concrete and the concrete in the adjacent slabs. Figure 4 shows a schematic for a spall repair patch adjacent to 2 joints. Figure 5 shows an actual repair adjacent to 2 joints ready to receive replacement concrete.

A neat cement grout made with high early strength cement is placed on the exposed concrete immediately prior to placement of the replacement concrete. The replacement concrete contains high early strength cement at the rate of 534 kg per cubic meter (900 lbs per cubic yard). The aggregate is a single size No. 7 (ASTM C 33), 19 mm (3/4 inch). The mix also contains polymer fibers (steel fibers were used until the recent past) to provide

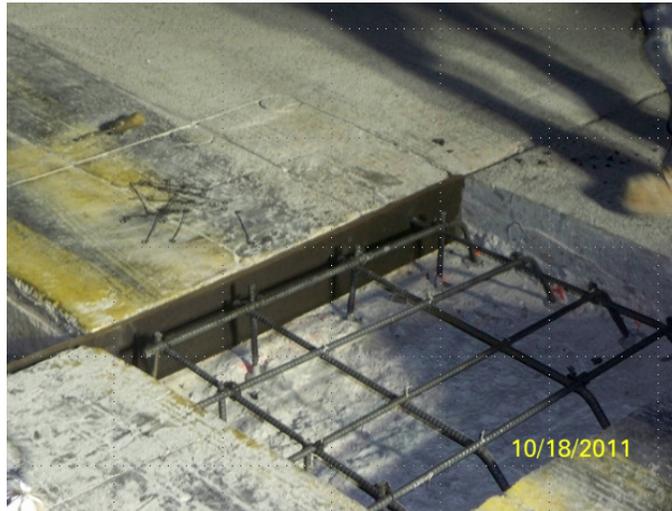
Figure 5: Spall repair showing reinforcing and tie bars to sound concrete below.

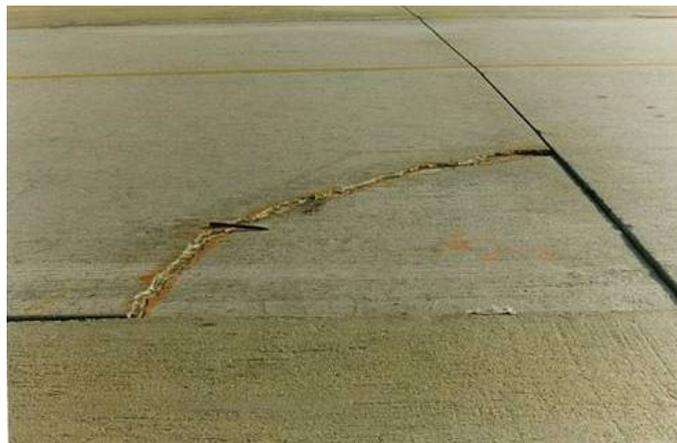
Figure 6: Typical corner crack distress in Taxiway E.

During the visual inspection, a DC-8 aircraft that had just landed was taxied along the taxiway in the area of distress. The corner of one slab in the middle lane of pavement was observed to deflect visibly from a distance of approximately 7.6 m (25 feet) as one of the gears of the aircraft traversed the slab at the corner. The corner of the PCC slab that was observed to deflect was not yet cracked. This slab was designated as Slab 37B.

It was concluded that many of the PCC slabs in Taxiway E in the area of distress had curled and separated from the CTB. The void between the bottom of the PCC and the top of the CTB appeared to increase as distance to the intersection of the transverse and longitudinal joint decreased. The lateral extent of curling exceeded 1.2 m (4 feet) from the corner as measured along the diagonal of the slabs. The amount of vertical curl at the corner was as much as 19 mm (3/4 inch) as measured in the hole after removal of the LDC.

The corners of the slabs were eventually cracking in fatigue under the repeated loads of the large commercial aircraft main gears that tracked at or very near the longitudinal and corner joints. The curling was attributed to drying shrinkage and/or temperature differentials between the top and bottom of the PCC slabs.

The repair plan was established as follows:

1. Saw cut the outer lanes of the PCC slabs longitudinally at a distance of 3.5 m (11.5 feet) from the longitudinal joint between the outer lanes and the adjacent middle lane of PCC slabs. The saw cut was to be made full-depth through the PCC, CTB, and into the top 76 mm (3 inches) of the SC.
2. An additional saw cut was to be made in the outer lanes of the PCC slabs longitudinally at a distance of 3.8 m (12.5 feet) from the longitudinal joint between

the outer lanes and the adjacent middle lane of PCC slabs. The saw cut was to be made full-depth through the PCC and CTB. The intent of this cut was to provide a "buffer" zone, 30 cm (12 inches) wide, to allow demolition and removal of PCC and CTB without damage to the pavement that was to remain in place after the repair.

3. Demolish and remove the middle lane and the "interior" portion of outer lanes of the PCC slabs and underlying CTB and SC.
4. Remove the remaining 30 cm (12 inch) wide buffer zone strip of PCC at the outer edge of the "interior" portion of outer lanes of the PCC slabs along with the underlying CTB and SC.
5. Construct 20 cm (8 inches) of CTB on top of the exposed subgrade.
6. Place 56 cm (22 inches) of PCC in two lanes, each 7.6 m (25 feet) wide. This configuration would put the main gears of large commercial aircraft in the middle portions of the new PCC slabs.
7. Saw cut transverse joints in the new PCC at a longitudinal spacing of 7.6 m (25 feet).
8. Seal the transverse and longitudinal joints and open to traffic.

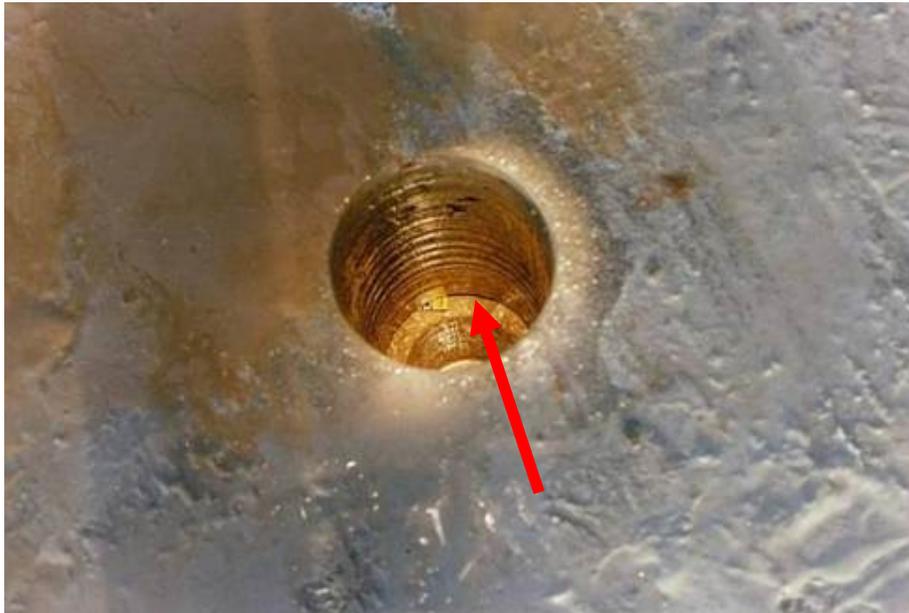
One coring/boring was located in the deflecting corner of Slab 37B approximately 1.2 m (4 feet) from the corner along the diagonal of the slab. A void approximately 3 to 6 mm (1/8 to

1/4 inch) thick was encountered beneath the PCC and the top of CTB as shown in Figure 7. Voids ranging from 3 to 6 mm (1/8 to 1/4 inch) between the PCC and the CTB were encountered in 9 of the remaining 15 corings/borings.

Figure 7: Void between PCC and CTB in the coring/boring in Slab 37B in Taxiway E.

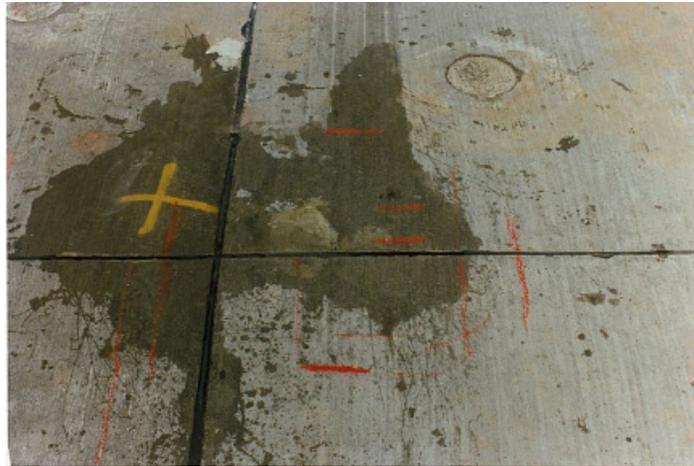
Figure 8: Epoxy used to lock void in place at LDC location (37B).

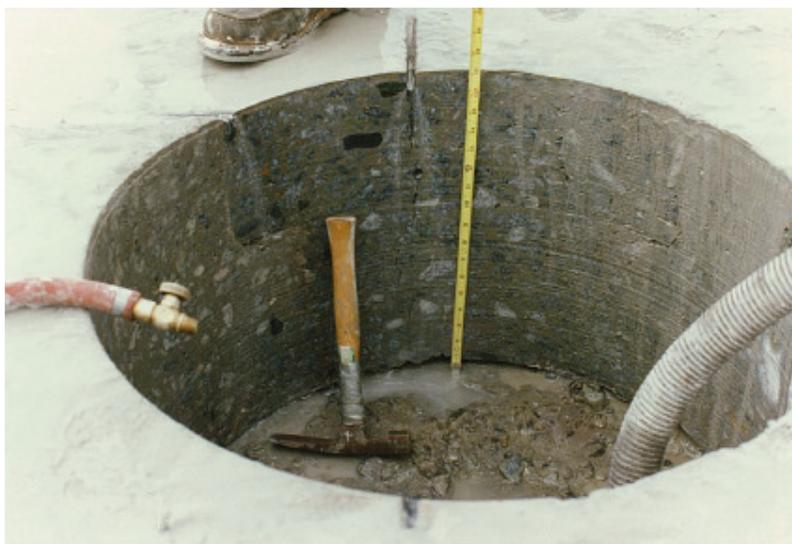
Figure 10: Void between bottom of PCC and CTB in LDC --- void is 19 mm (3/4 inch).

1. There was a void between the PCC and CTB approximately 3 to 19 mm (1/8 to 3/4 inch) thick near the intersection of the transverse and longitudinal joint (see Figure 10. This was significantly greater than the 3 to 6 mm (1/8 to 1/4 inch) void at the coring/boring location that was approximately 1.2 m (4 feet) from the intersection of the transverse and longitudinal joints along the diagonal of the slab. This indicates that the thickness of the void increased with decreased distance from the intersection. The void also existed beneath Slab 36B on the other side of the transverse joint. The slabs were curled upward at the corners.

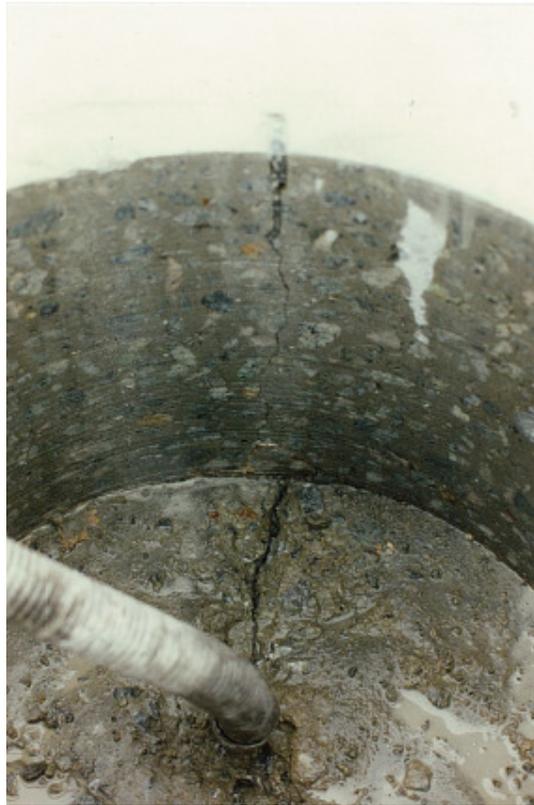
Figure 11: "Sympathetic" crack in CTB below transverse joint crack in PCC in the LDC.

2. The cracked portion of the transverse joint below the saw cut exhibited an opening of approximately 3 mm (1/8 inch) in the "joint".
3. There was a "sympathetic" crack in the CTB beneath the cracked portion of the PCC below transverse joint saw cut as shown in Figure 11. This indicates that the CTB likely cracked when the concrete above it cracked below the transverse joint saw cut.

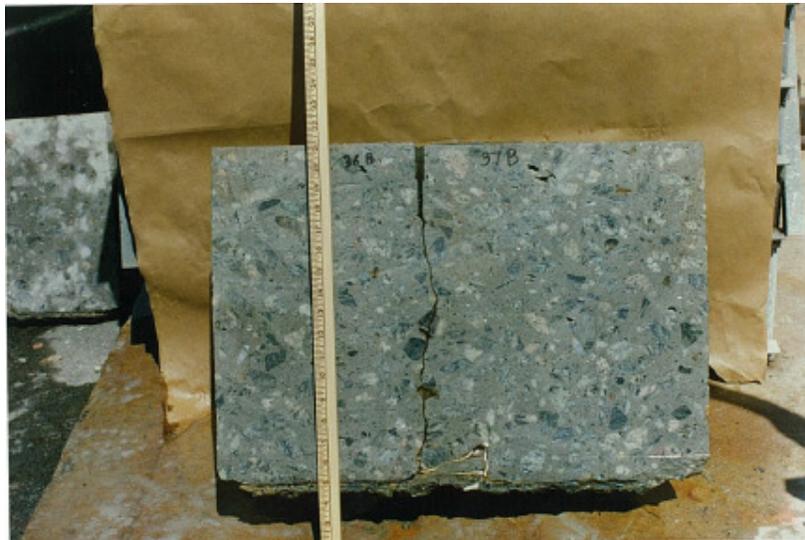
Figure 13: Slice of LDC with embedded dowel bar.

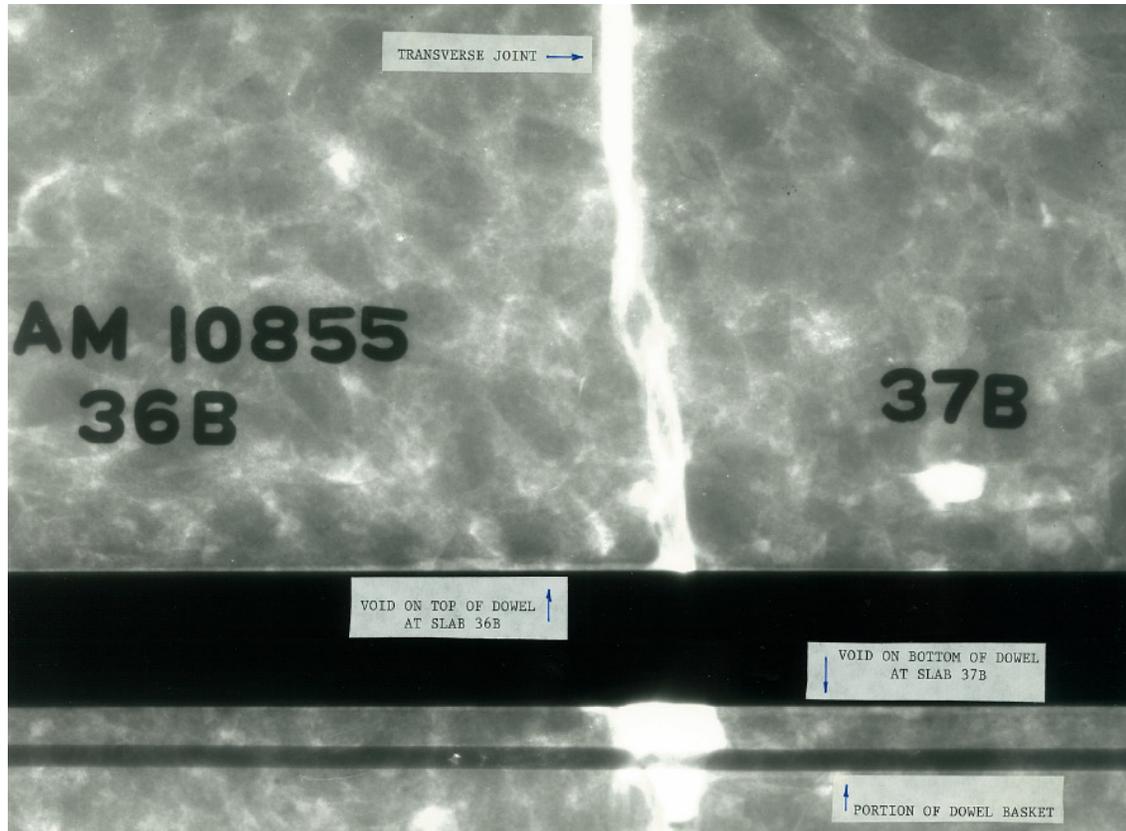
Figure 14: X-ray image of slice from LDC with embedded dowel bar.

1. There was a small void on the top of the dowel on the "upstream" side (Slab 36B) of the transverse joint and small void on the bottom of the dowel on the "downstream" side (Slab 37B) of the transverse joint as shown in Figure 14. An examination of the void around the dowel indicated that the dowel was likely cast with a small void around it rather than the small void being the result of "wearing" of the dowel in the dowel hole. The cause of the small void around the dowel could not be determined with certainty. However, it could be the result of a slight amount of excess oil on the dowel at the time of construction or possibly due to a small shift in the position of the dowel while the concrete was still in a plastic state.

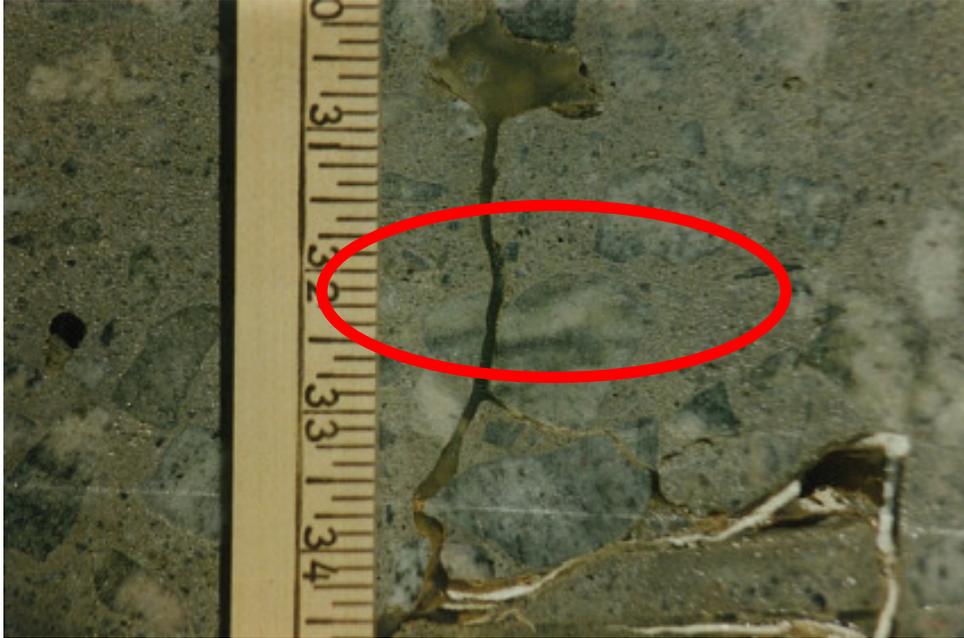
2. The granitic gneiss large aggregate shown in Figure 15 indicates a vertical offset of 3 mm (1/8 inch) across the crack in the aggregate at the cracked portion of the transverse joint below the saw cut. This vertical offset matches that observed across the transverse joint at the top of the core.

4. A styrofoam coffee cup was found cast into the concrete at the bottom of the PCC in the LDC. It was the opinion of the investigators that this did not have any effect on the issue of curling or cracking.

Figure 15: Note the vertical offset of 3 mm (1/8 inch) in the large aggregate. The styrofoam coffee cup (white material) was determined to be of no influence.

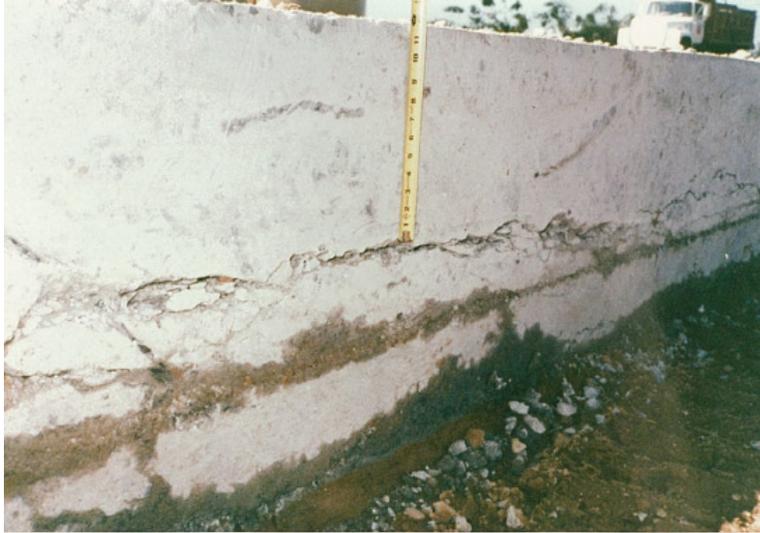
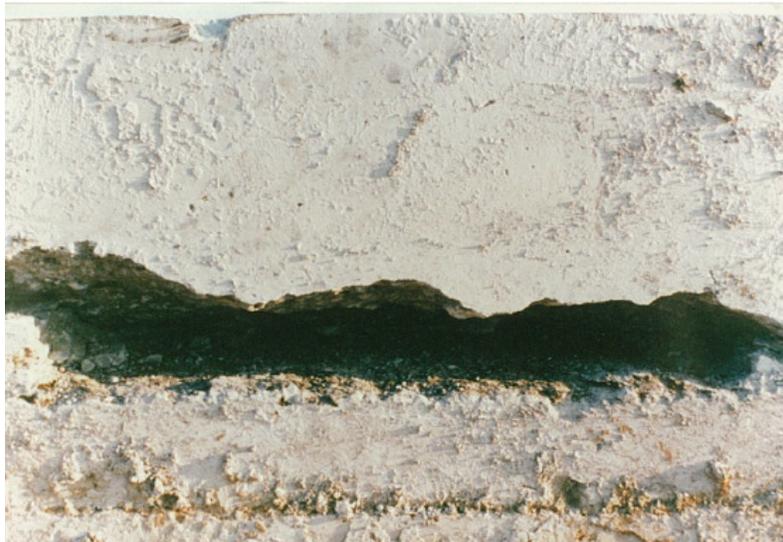
When the contractor removed the crushed PCC from between the two interior saw cuts, portions of the underneath side of the PCC slabs in the buffer zone were observed to have cracked, sheared, and broken. The cracked, sheared, and broken zone was evident in the bottom half of the PCC in the face of the 30 cm (12 inches) buffer zone strip of PCC. The shear was triangular in nature in a direction perpendicular to the face, the thickness decreased with increased depth into the face. The thickness of the shear break was typically in the range of 10 to 20 cm (4 to 8 inches) at the exposed face of the PCC and feathered out at 30 to 45 cm (12 to 18 inches) into the PCC. This indicated that the broken zone could extend as much as 15 cm (6 inches) into the PCC that was to remain in place after removal of the buffer zone. Figures 16 and 17 illustrate the cracked and sheared zone in the face of the PCC and the lateral extent into the PCC.

Figure 16: Typical cracked and sheared zone in saw cut face of PCC slab.

Figure 17: Cracked and sheared zone with pieces removed (Note depth into the PCC).

It was concluded that the headache ball was dropped too close to the saw cut and the crushed concrete was “bulking outward” against the vertical cut face of the buffer zone and the buffer zone concrete was applying a downward force on the face of the PCC that was to remain in place. This was supported by the fact that the outer second saw cut was that was observed to be closed; thereby indicating the buffer zone had moved outward. The downward shear forces were breaking or shearing the bottom of the buffer zone and the PCC slabs that were to remain in place. None of the cracking observed during the construction was encountered during the Engineering Investigation prior to the repair construction activities. Vibration monitoring was also performed during drops of the headache ball and indicated that the vibration velocities during the dropping of the headache ball were not high enough to cause cracking due to vibration.

The solution was to make a third longitudinal saw cut that was an additional 30 cm (12 inches) laterally beyond the buffer zone. This additional section of PCC was removed and

this contained the sheared or broken zone at the bottom of the slabs. The contact location of the headache ball was also kept at least 1.8 m (6 feet) away from the additional longitudinal saw cut for the slab removal. The additional saw cut resulted in replacement slabs that were 7.9 m (26 feet) wide. No additional cracked or sheared zones were encountered after the change.

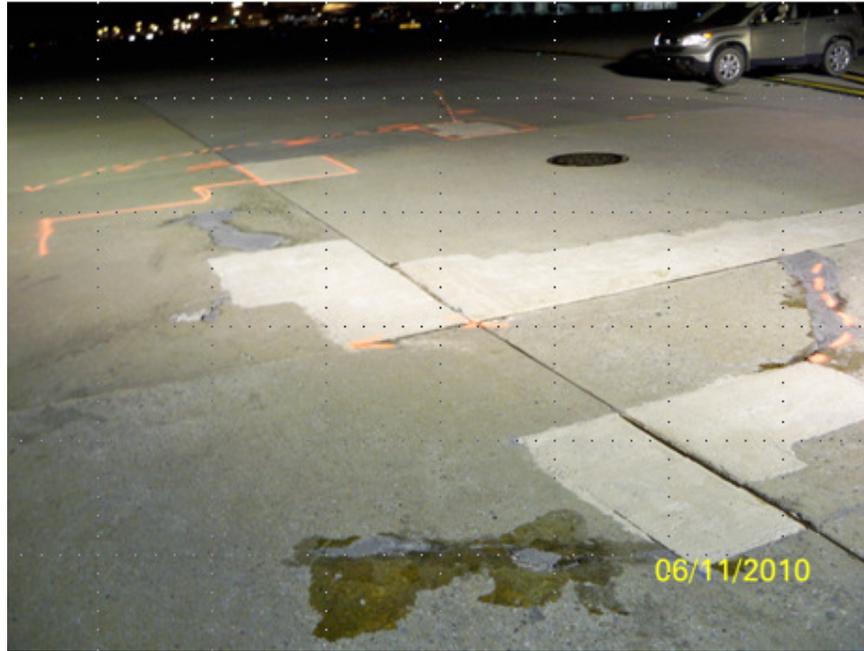
During the Annual Inspection Program as well as more frequent routine general observations, significant distress was first noted around a Utility Slab in the intersection area of Taxiway D and Taxiway L in 2010. The initial distress at this location consisted of localized small spalls that had been repaired previously with routine procedures. These included sealing cracks and patching spalls in six slabs around a heavily reinforced utility slab associated with a manhole and underground drainage lines. The utility slab also had patches in it. The manhole was approximately 1.8 m (6 feet) in diameter and had an invert approximately 4.3 m (14 feet) below the pavement surface. The manhole structure served three incoming drainage pipes and one outgoing drainage pipe that were near the invert of the manhole structure. The incoming pipes included two reinforced concrete drainage pipes (RCP) approximately 40 cm (16 inches) in diameter and a corrugated metal pipe (CMP) approximately 61 cm (24 inches) in diameter. Monitoring over time indicated the need for additional spall repairs. Also, the observations indicated the initiation of cracks within the slabs in the area and indications of shallow depression of the pavement surface. The affected area encompassed 7 slabs that were each 7.6 m (25 feet) by 7.6 m (25 feet). Figure 18 shows the area of concern on June 11, 2010. The depth of the depression was not determined but was visible to the unaided eye.

Figure 18: General view of Utility Slab and distressed area in Taxiway D and L on June 11, 2010.

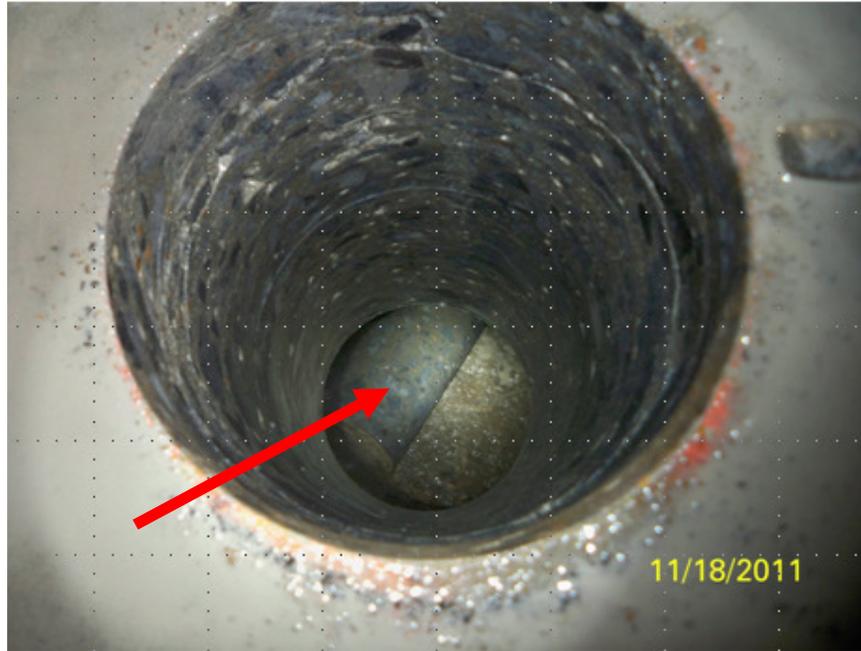
On November 18, 2011, three cores of the PCC were obtained in the area of depression. At one location, when the PCC was finally penetrated, the 46 cm (18 inches) long concrete core dropped out of the core barrel and onto its side at the bottom of a void at the bottom of the PCC. No CTB or SC was found beneath the PCC. The void was determined to have a depth of 63 cm (25 inches). Figure 19 shows the core laying on its side in the void. One of the other cores indicated a void beneath the SC. No void was found at the third core location.

Figure 19: Core, 46 cm (18 inches) long, lying on its side at bottom of void beneath the PCC.

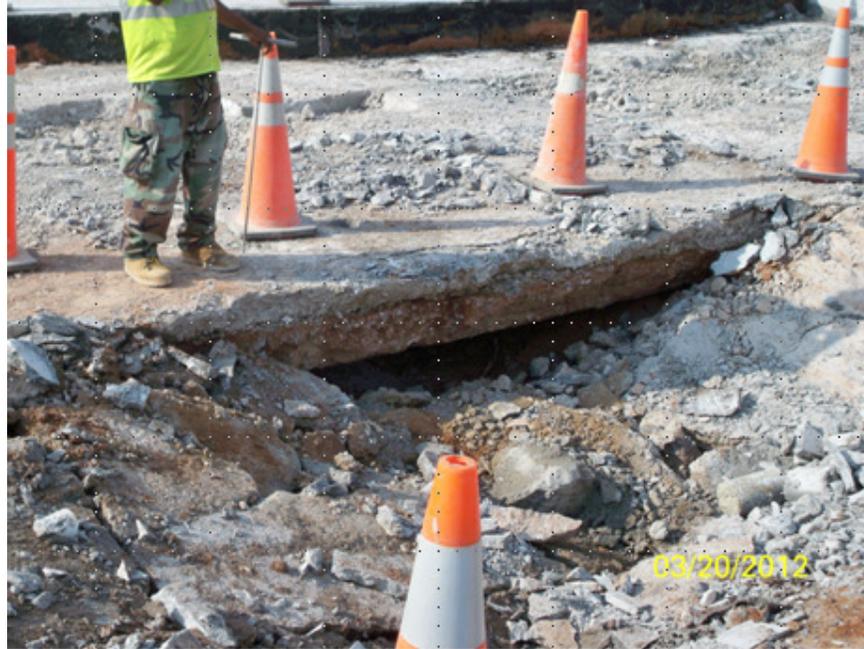
Figure 20 shows the void beneath the SC and CTB. The PCC has been removed from the top of the CTB. Figure 21 shows the CMP drain line and the void where soil was being lost into an opening in the CMP that had not been properly plugged.

Figure 20: View of void beneath SC and CTB observed during the demolition in the preliminary repair procedures (PCC has been removed).

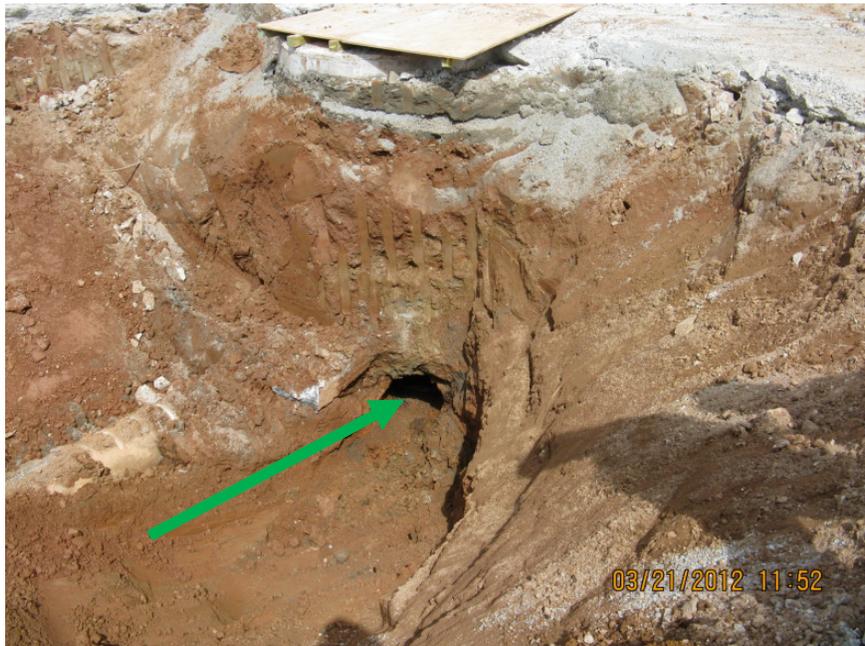
Figure 21: Void and loss of soil in opening in improperly plugged abandoned CMP drain line.

Based on the results of the preliminary repair plan and excavation, the final repair consisted of properly plugging the hole in the manhole structure where the CMP entered. The outside

of the plug was filled with the placement of approximately 76 cm (30 inches) of flowable cementitious backfill (FCB). The FCB was specified to achieve a compressive strength of 1380 kPa (200 psi) at 28 days. The mix used exhibited a compressive strength of 2620 kPa (380 psi) at 7 days because the area could not be closed for 28 days. Figure 22 shows the placement of the FCB in the excavation. The FCB was covered with compacted M-10 sand to within 72 cm (29 inches) of the top of the surrounding pavement that was to be left in place. The M-10 sand was compacted to 95% of modified Proctor dry density. Figure 23 shows the placement of the M-10 sand.

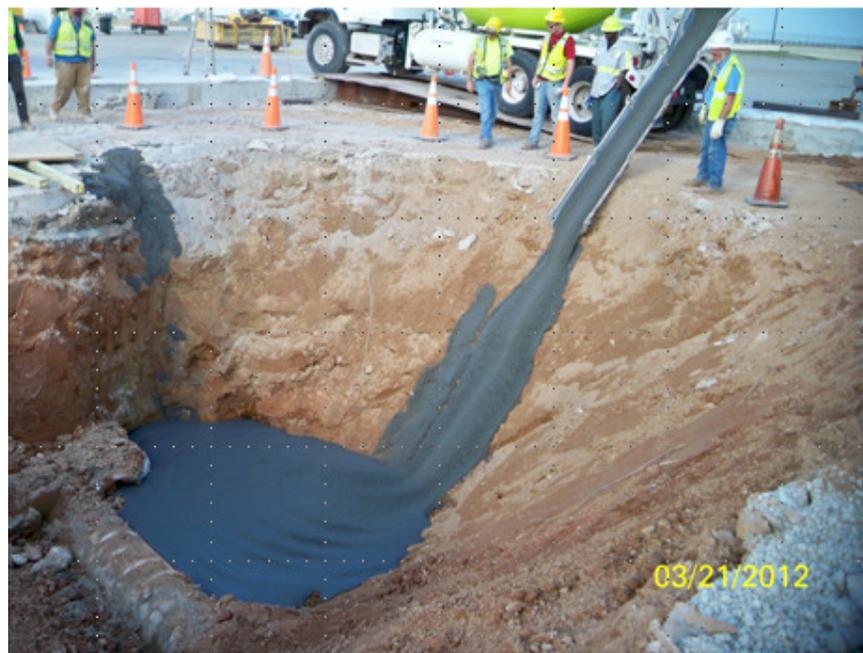
Figure 22: Placement of FCB around the plug in the manhole structure where the CMP entered the manhole.

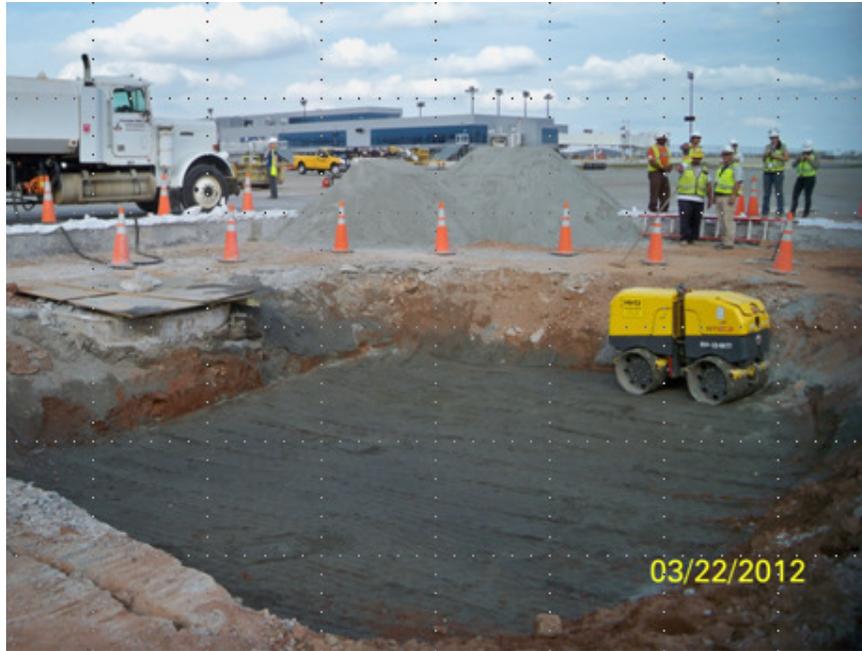
Figure 23: Compaction of M-10 sand above the flowable fill.

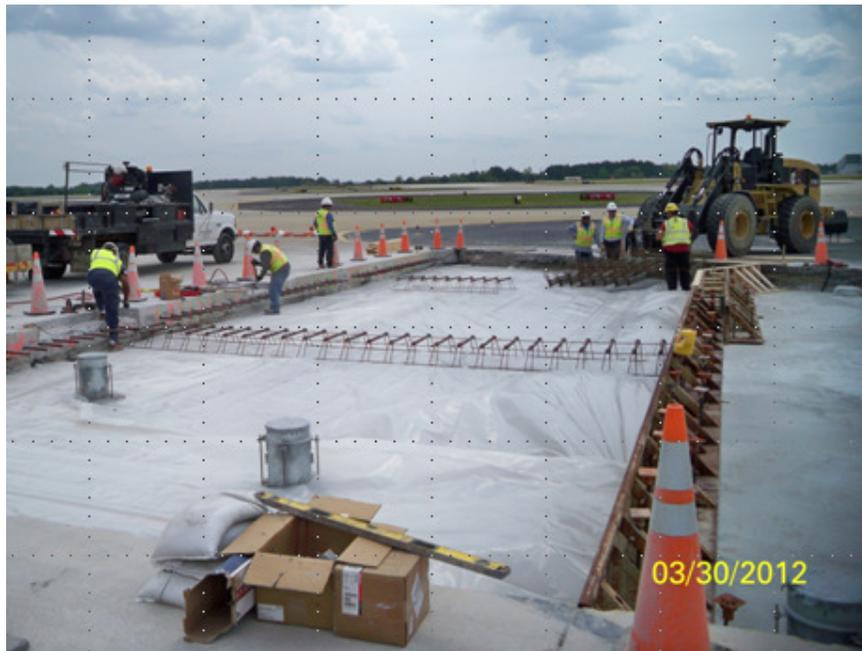
Figure 24: Repair area ready for placement of PCC.

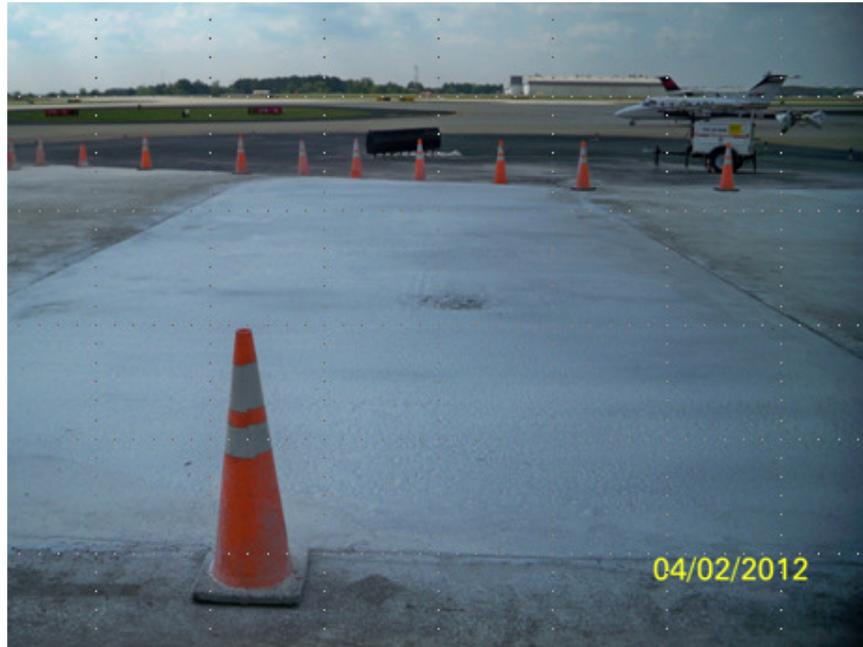
Figure 25: View of completed PCC pavement.
