TITLE: *Reconstruction of Runway 9R-27L at Hartsfield Atlanta International Airport. The 33-Day Wonder – a Case History*

AUTHOR(S): Anu Saxena, D.S. Saxena, Subash Reddy Kuchikulla, Daniel Molloy, and Frank O. Hayes

VENUE: *Proceedings, International Congress, Challenges of Concrete Construction, University of Dundee, Scotland*

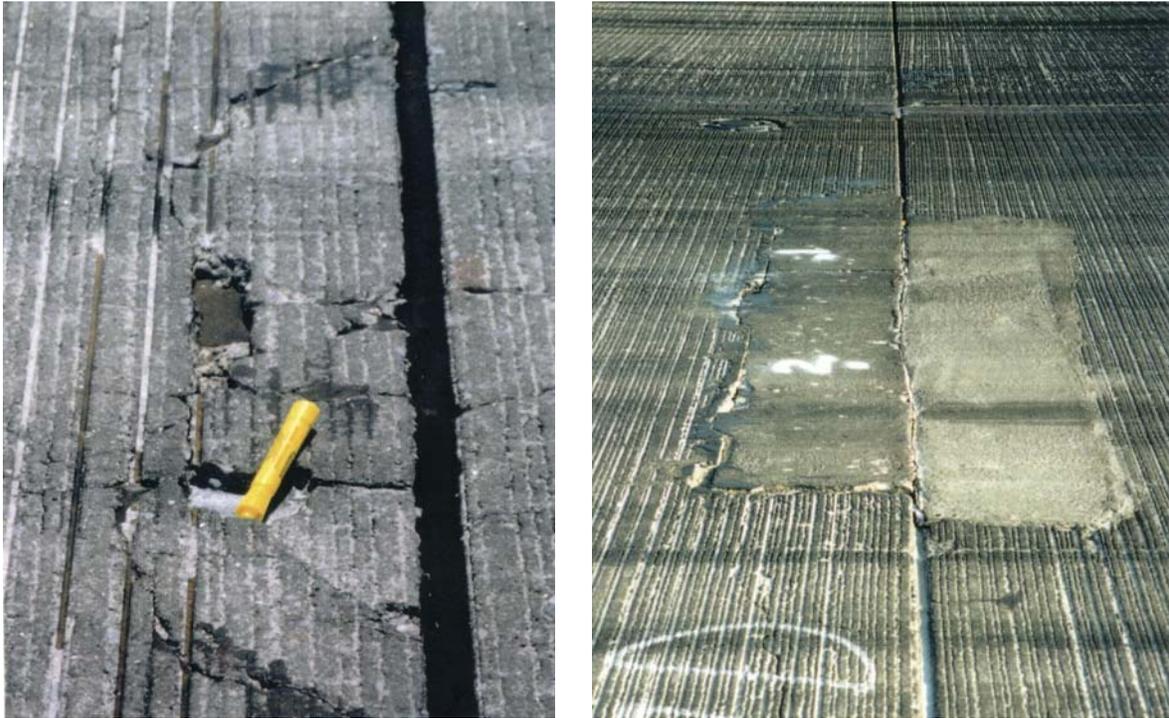
Figure 1 Typical Joint Distress

Results of the 1997 study indicated the Pavement Condition Index (PCI) of the runways ranged from 53 to 97 with most values in excess of 70. The predominate distress observed was widespread map cracking in each of the runways. In Runway 9R-27L in particular, the joint distress was manifested into localized spall features which were increasing at an accelerating rate, as illustrated in Figure 1. It was noted that while the overall condition of Runway 8R-26L would appear lower than that of Runway 9R-27L, the results of PCI data indicate that 9R-27L was deteriorating at a faster rate than Runway 8R-26L, particularly with respect to the pavement keel or center section. Table 1 summarizes 1997 PCI Data for all ATL runways.

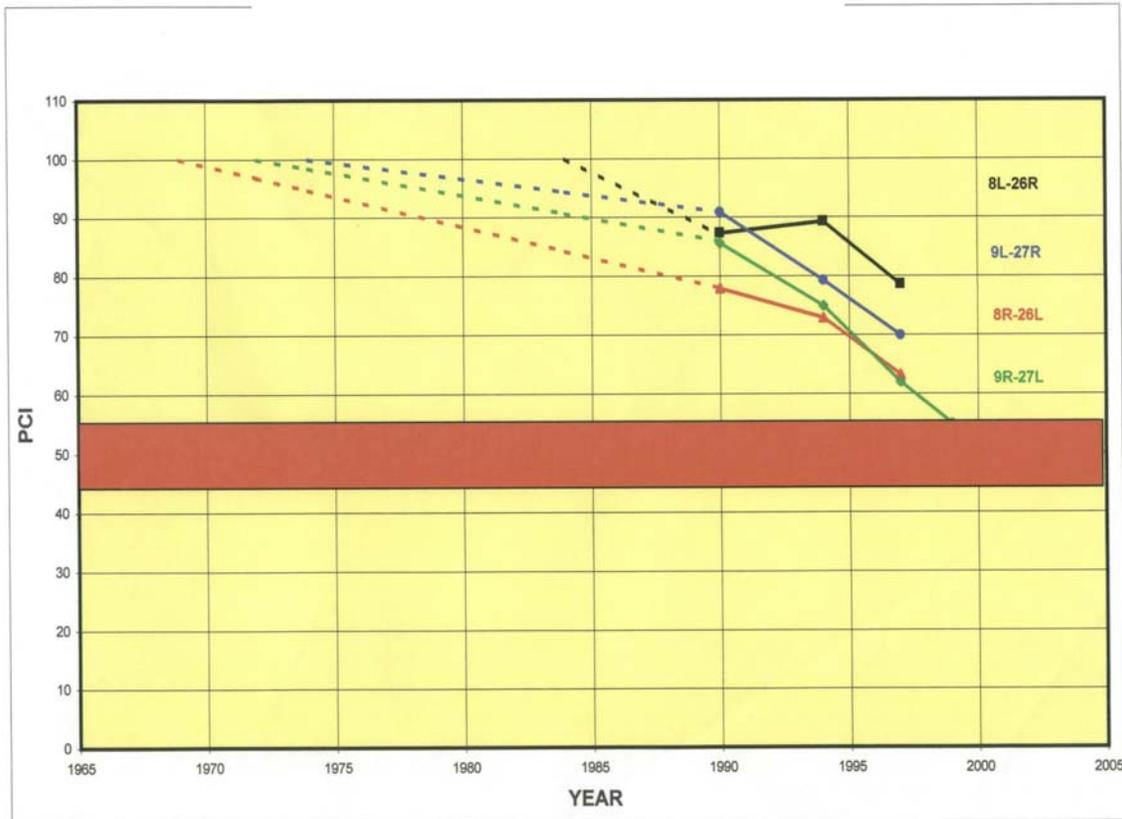
Figure 2 Trend Comparisons for PCI Values of All Runways at ATL

Figure 2 illustrates chronological trends of PCI for center pavement sections of the ATL runways.

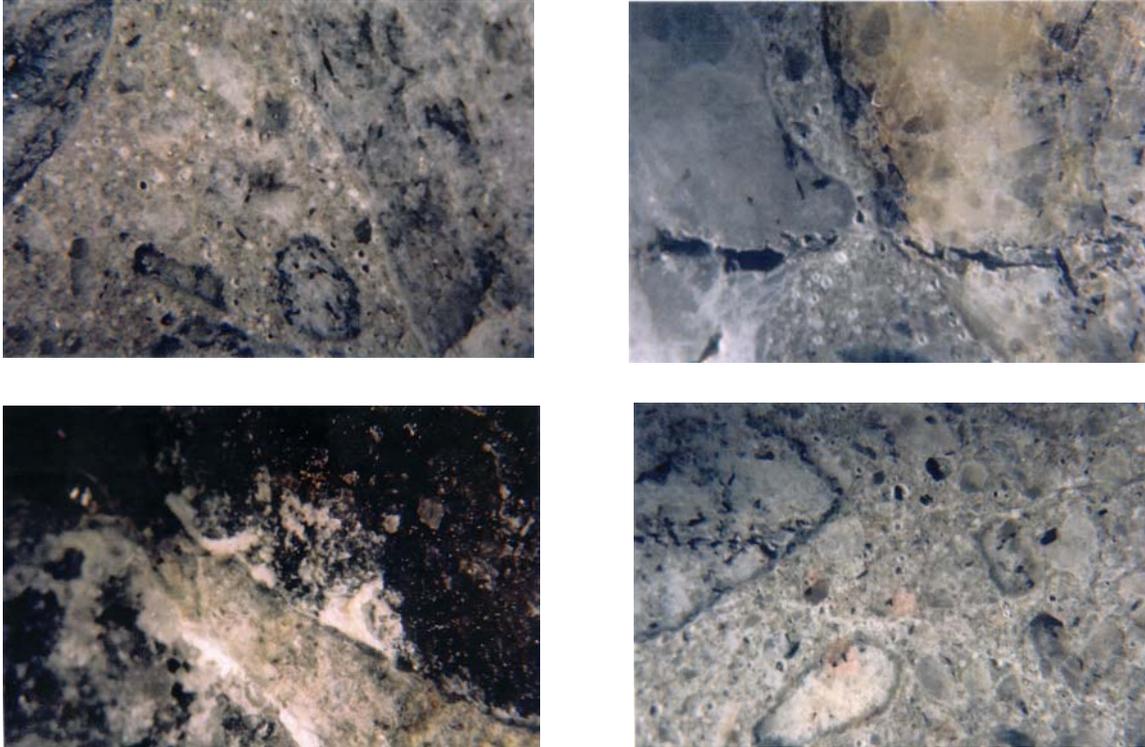
Figure 3 Indications of ASR Deterioration

During both the 1997 Pavement Evaluation and 1999 PCI Survey, evidence of alkali-silica reactivity (ASR) was observed in concrete cores from all 4 runways, as illustrated in Figure 3. The reactions appeared most severe in Runways 9R-27L and 8R-26L. Voids in the concrete matrix in these runways appeared nearly filled with the gel product of ASR. Furthermore, horizontal cracks within the top 15 cm (6 in.) were observed in cores from Runway 9R-27L. The spalling and surface cracks observed in Runway 9R-27L were load-associated and eth distress appeared to have been accelerated as a result of ASR. It was further noted that the ASR appeared worse in concrete pavement using Portland cement and less severe in concrete using slag cement.

Together, these observations in Runway 9R-27L indicated ASR had in fact contributed to the deterioration of the concrete pavement to a point where replacement of the runway was considered necessary.

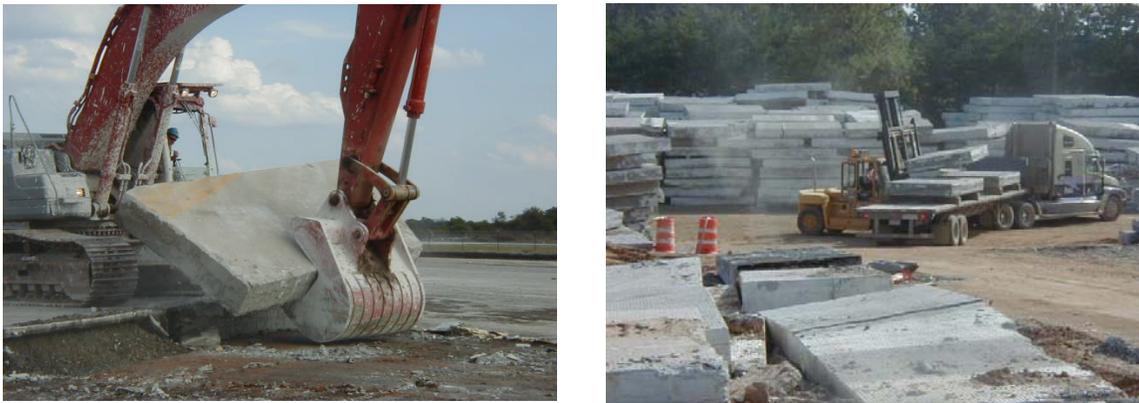
Figure 4 Removal of Existing Pavements

A critical phase of the construction project was the removal of some 21,150 concrete panels, each measuring 2.3 m by 3.7 m (7.5 ft by 12 ft) by 406 mm to 559 mm (16 to 22 in.) thick. A specialty contractor, Penhall Company, was chosen for this task based on their experience in California with removal of earthquake-damaged bridges and interstates following major California earthquakes. Penhall mobilized multiple teams of operators and equipment from across the country to complete the task. Once the existing concrete slabs were cut, unique pavement removal buckets were utilized to carry away a maximum of three 9,150-kg (20,150-lb) panels onto each flat bed truck for transport to a 5.7-ha (14-ac) stockpile yard accommodating some 1,900,000 kN (213,000 tons) of panels stacked on top of one another, sometimes as high as 13 panels (refer to Figure 4).

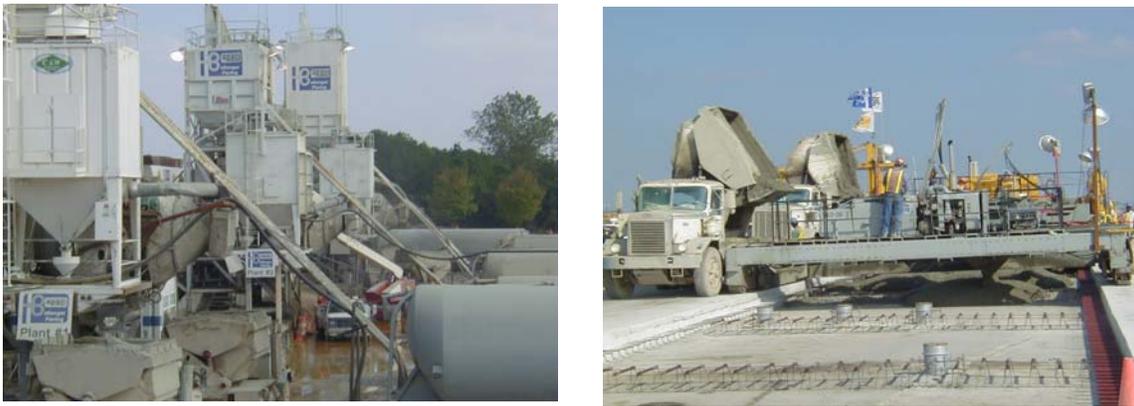
Figure 5 Batching and Placement of Concrete

The resource needs for this project were significant, including: I) 1,200+ workers working 24 hours per day, 7 days per week at the height of construction ; 2) 200 to 300 truck loads of materials per day; iii) three on-site concrete batch plants (refer to Figure 5), plus an existing off-site commercial batch plant as backup, each capable of producing as much as 7.7 cu m (10 cu yds) per min.
