TITLE: *Innovative and Durable Repair Solutions for Concrete Pavement at Hartsfield-Jackson Atlanta International Airport*

AUTHOR(S): W. Charles Greer, Jr., Subash Reddy Kuchikulla, John Rone, and James L. Drinkard

VENUE: *Proceedings, 12th International Symposium on Concrete Roads, organized by the European Concrete Paving Association EUPAVE and the Czech Research Institute, Prague, Czech Republic*

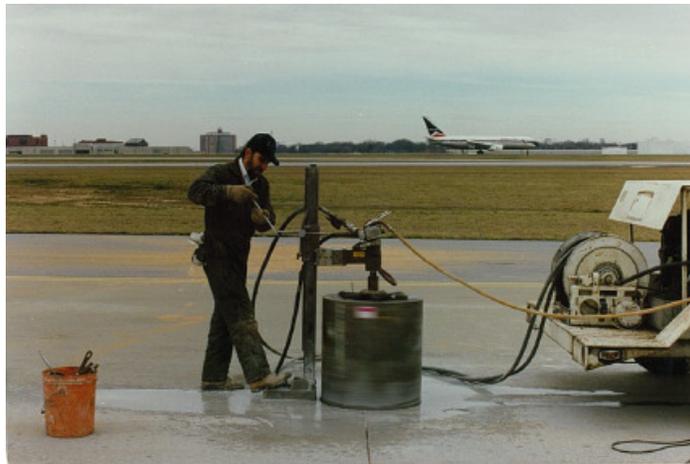
Figure 9: Coring operation for LDC.

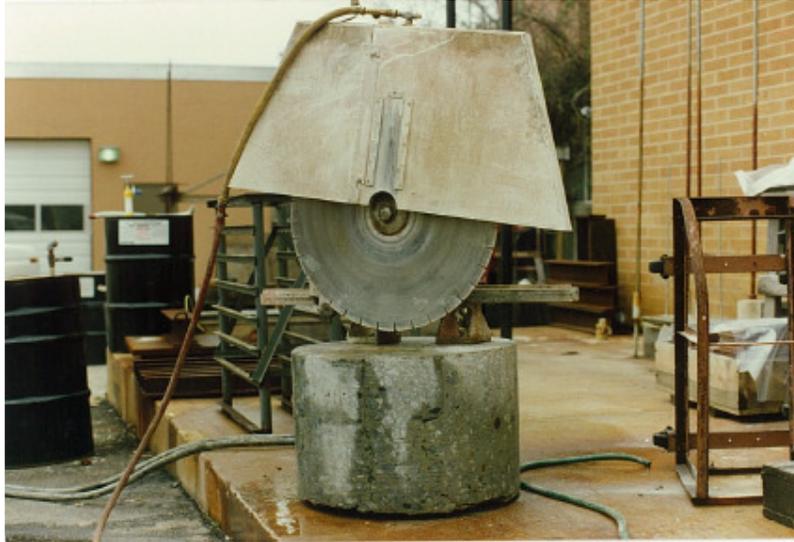
The LDC was returned to the laboratory where it was sawed such that an approximately 10 cm (4 inch) wide vertical slice (top to bottom) could be obtained. The slice was positioned so that the dowel nearest the corner in Slab 37B was contained near the mid-width of the slice. Figure 12 shows the sawing equipment set-up on top of the LDC. Figure 13 shows the slice after sawing.

Figure 12: Set-up for sawing of LDC at laboratory.
